North Sea Wrecks

Example: UB61

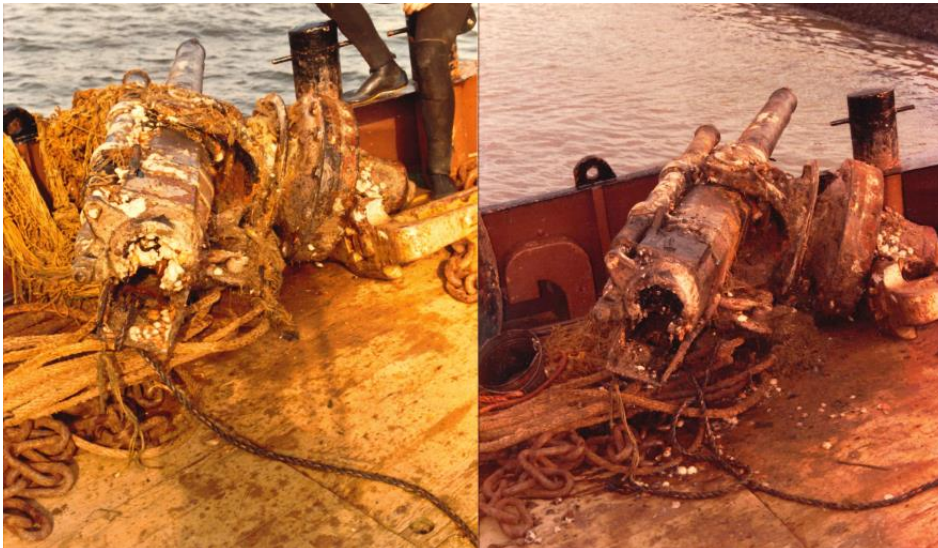
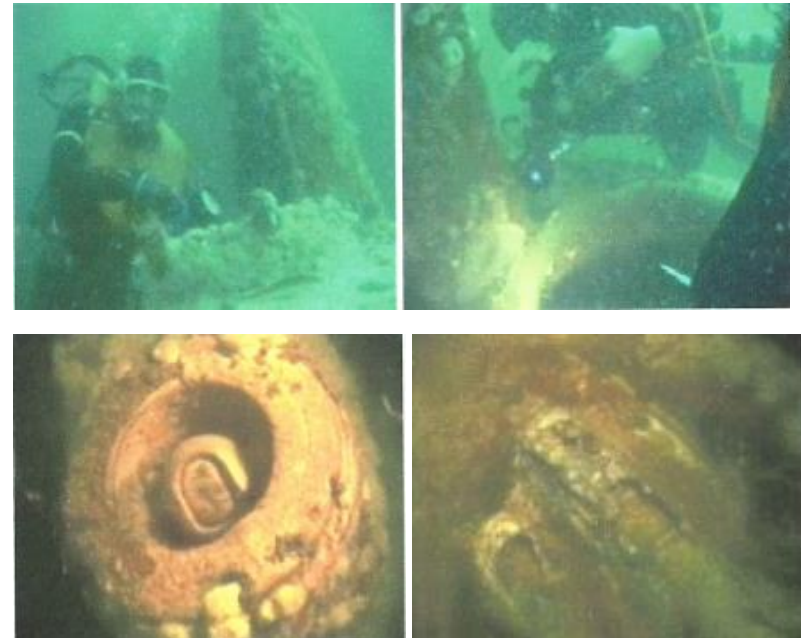
Earlier dives on the UB61, salvage / looting

- 1986:
 - wreck is found and deck gun salvaged by dive club 'Ecuador'
 - Dive photos taken, baseline for wreck condition
- 1986>:
 - regular visits by wreck divers
 - 'hearsay' is that all visible elements including munitions have been removed

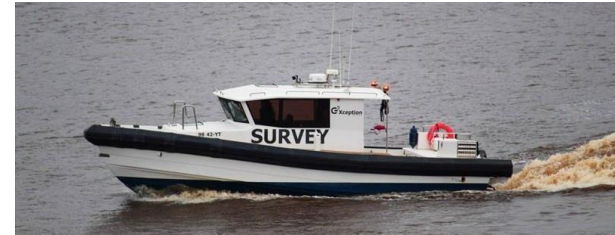
NL North Sea Wrecks Survey campaign

Nov 2018: MBES / SSS survey - RV Octans,
– UB61, Max Gundelach, Dirk von Minden, Stolzenfels
July 2020: High resolution MBES - Xception (G2),
– UB61, Max Gundelach, Dirk von Minden

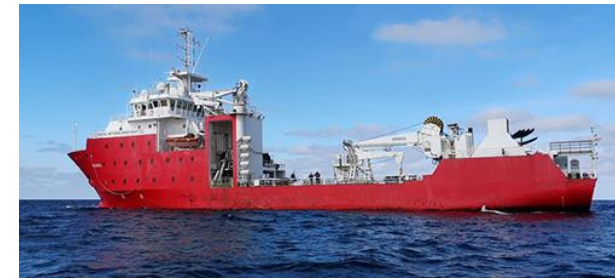
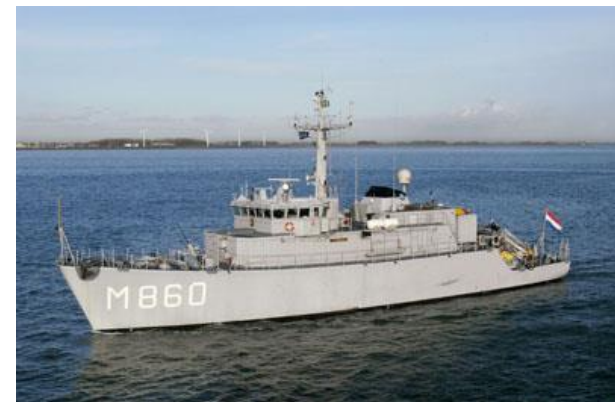
2021:

April: High resolution MBES - Xception (G2),
– UB61, Max Gundelach, Dirk von Minden, Stolzenfels
May: High resolution SAS - HNIMS Geosea
– UB61 and Max Gundelach
June: Diving, sampling - HNIMS Geosea
– UB61, Max Gundelach
August: Diving, sampling - HNIMS Schiedam
– Max Gundelach, UB61

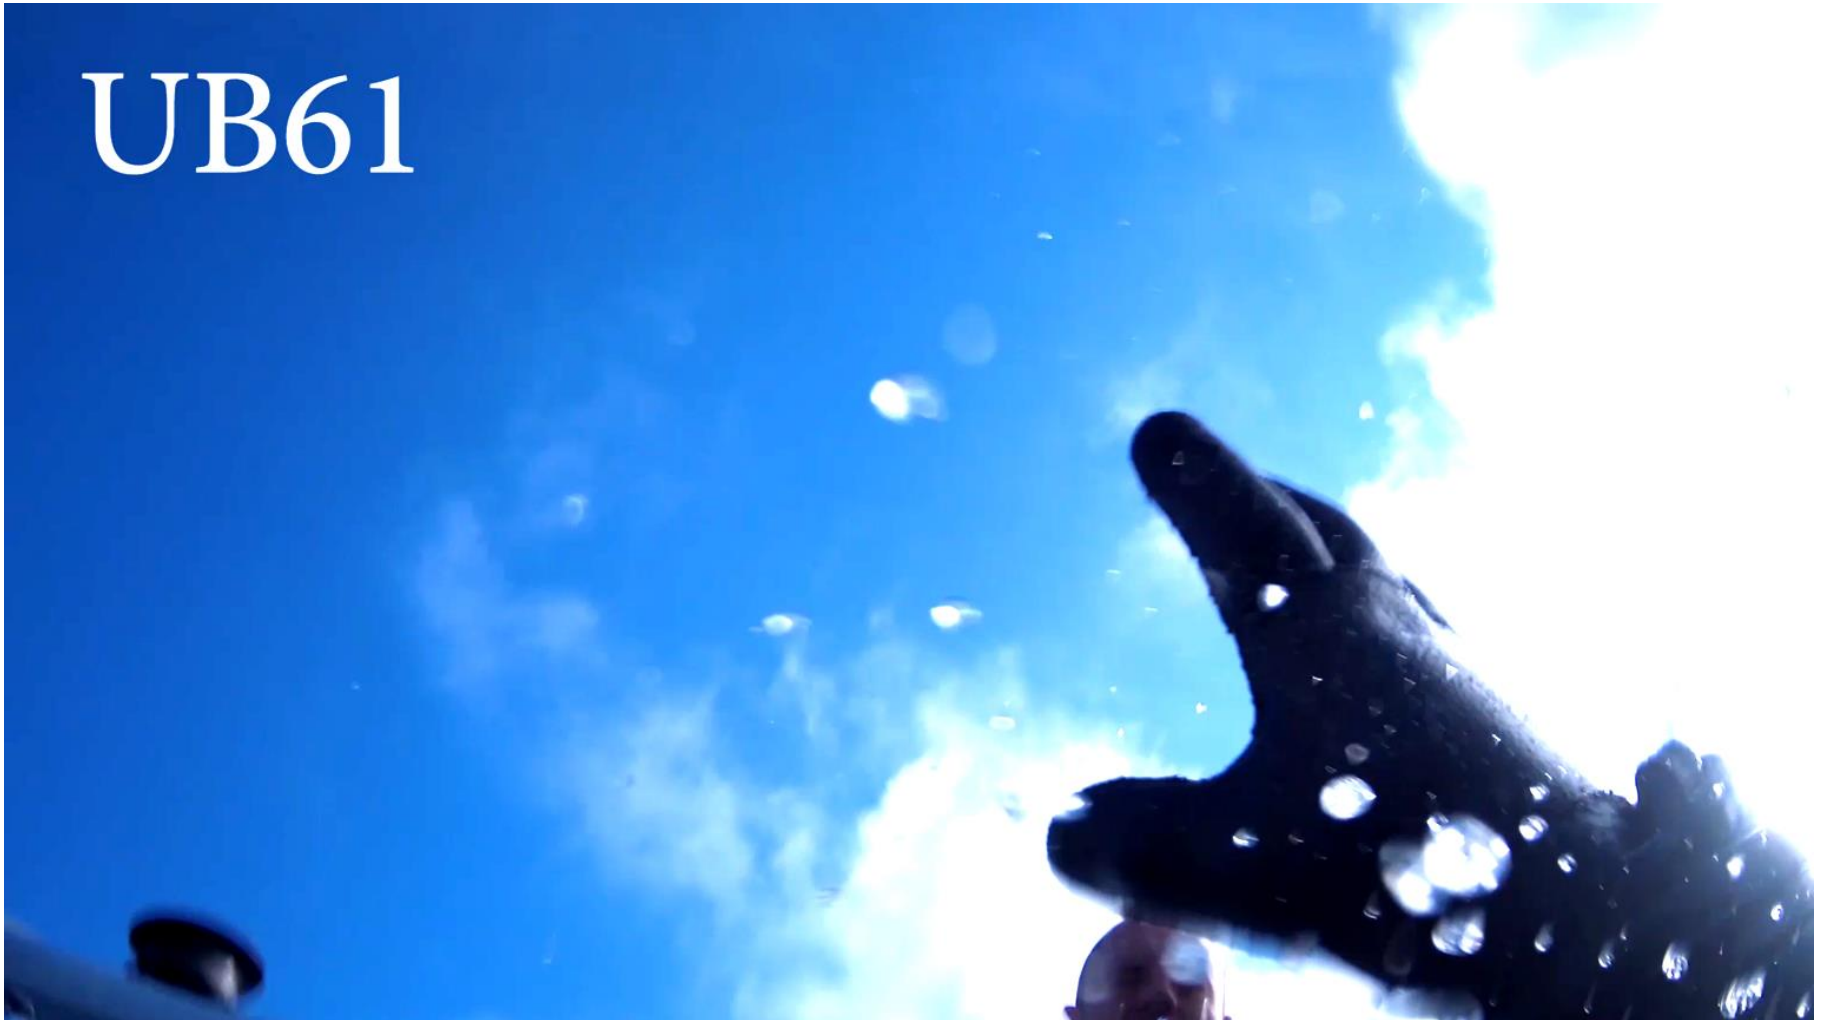
UB61 – Dive results

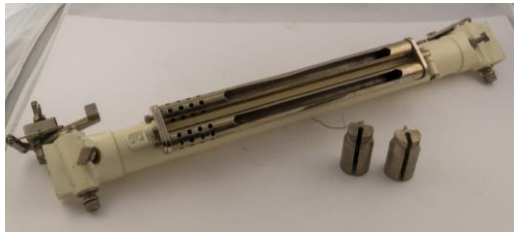
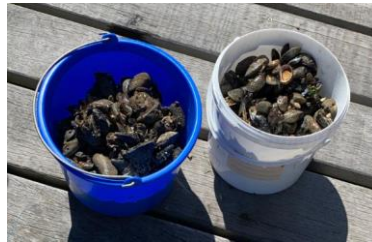
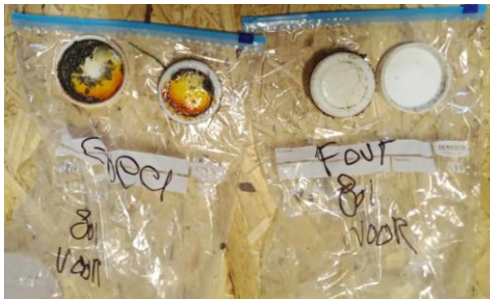
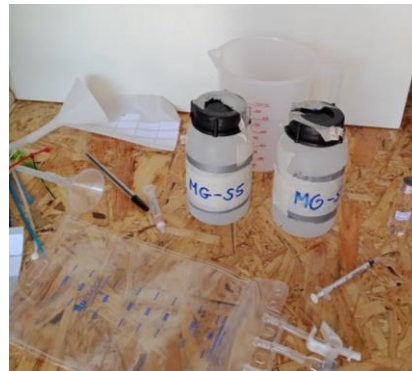
Sampling

- Bottom samples @ 5, 10 and 25 meters offset N, S, E, W
- Water samples @ 5, 10 and 25 meters offset N, S, E, W
- Passive samplers (2 cages with 2 samplers per wreck)
- ~~Mussels at 3 locations per wreck~~

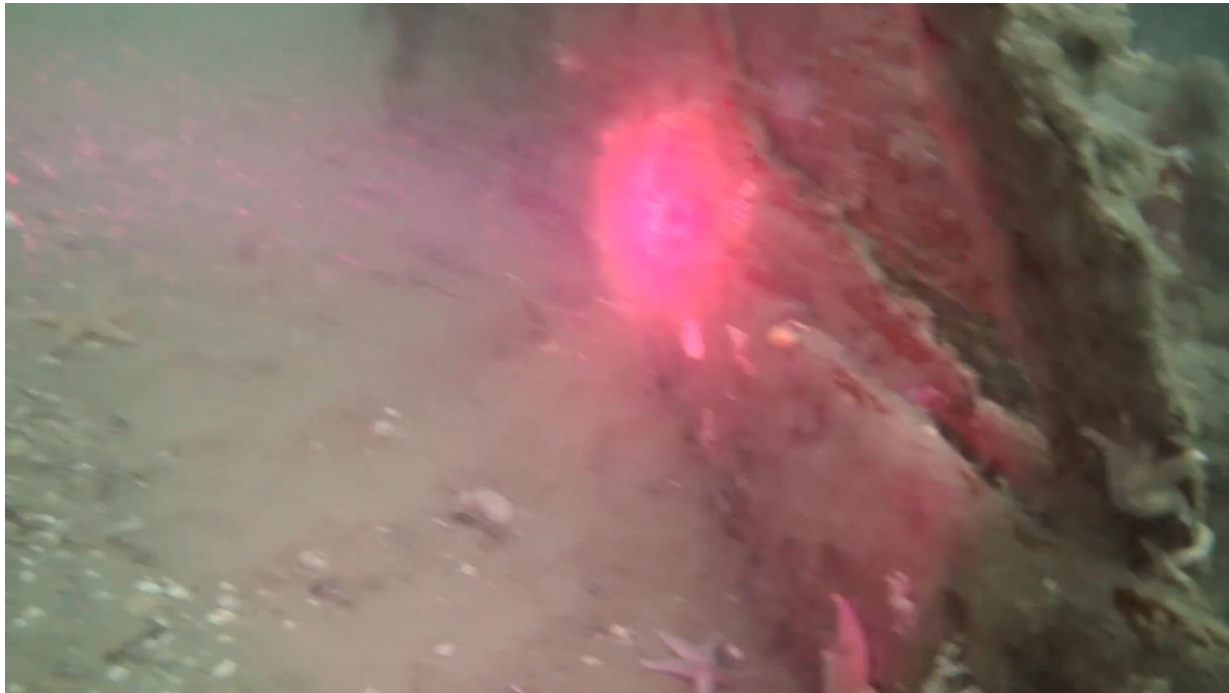
Issues during sampling

- Some cages with passive samplers gone after storms
- Mussels died before deployment (weather standby)
- Labeling requires attention
- Visibility is an issue for state determination
